ENGINE OIL PUMP MEASUREMENT POSITION UPDATE

NO. TSB-89-11-007

DATE November, 1989

MODEL 1988 to 1989 Models

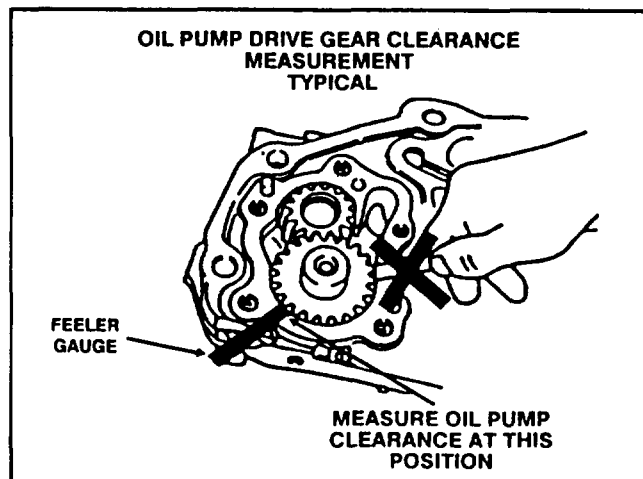
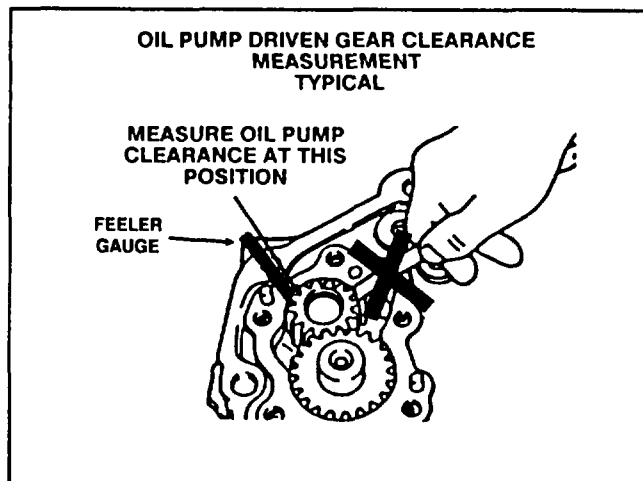
In order to increase service accuracy, the oil pump gear tip measurement position has been moved. Shown in figures 1 and 2 the correct places to measure the clearance on both the drive gear and the driven gear. Please make the indicated changes to the service manuals listed below and write this TSB number in the TSB revision boxes on the affected pages. Clearance specifications have not changed. Please refer to the Service Manual for clearance specifications.
